Manhole Inspection Summary

Manhole # S45II_044MH

Insp Date: **4/30/08 6:53 AM**

Location Address: **Federal St**

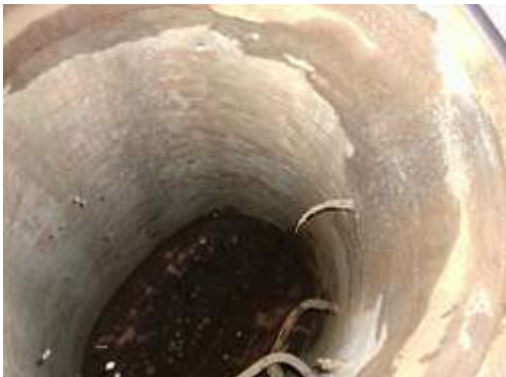
Defect 2

☒ **Leaks**

Frame Leaks

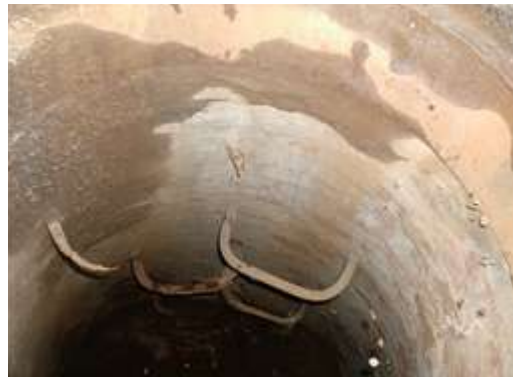
Defect 1

Infiltration: ☐ None ☒ **Joint** ☐ Cracks ☒ **Mortar** ☐ Roots ☐ Wall

Infiltration

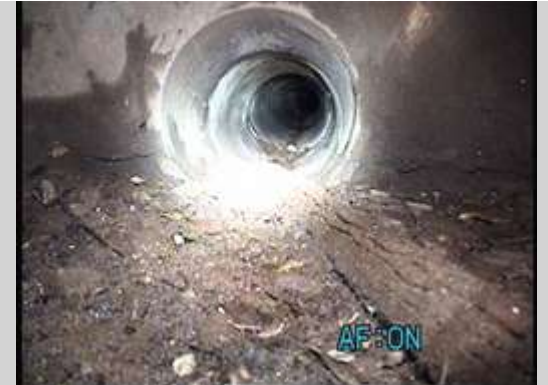
12 O'Clock Outflow

8 in. Circular Gravity Sewer
Pipe Out @ 12 O'Clock

Deposits: ☐ None ☐ Mud ☐ Sludge ☒ **Debris** ☐ Grease

Silt Depth: **1** (in.) Deposits Extent: **Light**
